420 SEL 1991
After CerBond® Treatment

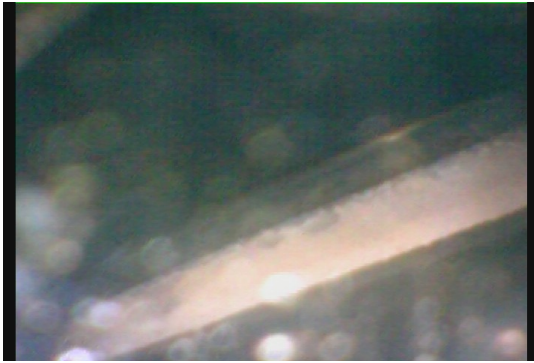
Valve

“Re-inspection, following a CerBond® treatment and driving the vehicle for 1,500+ miles, confirmed performance degrading carbon build up has been basically eliminated. These after pictures show the metal minus the carbon build up. The intake valve and the piston crown both are carbon free and marks where the carbon had built up in thick layers is now visible in a few areas. Cylinder walls are now shiny and actually have a transparent amber coating seal.”
